RM No. E7J23

RESEARCH MEMORANDUM

CYCLIC ENGINE TEST OF CAST VITALLIUM TURBINE BUCKETS - I

By J. Elmo Farmer, F. N. Darmara
and Francis D. Poulson

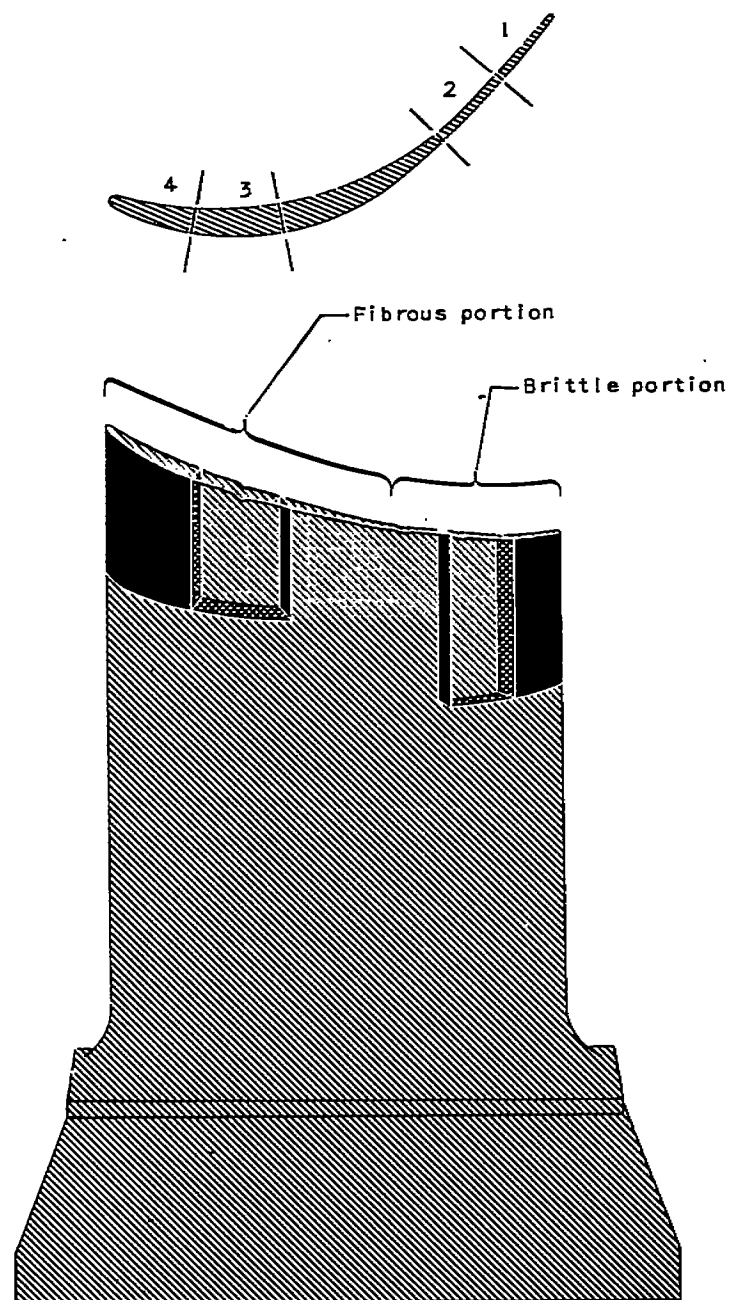
Microexamination. - Two samples were cut from both the leading and the trailing edges of the broken buckets. The locations from which the samples were taken are shown in figure 5. The samples were polished and electrolytically etched in hydrochloric acid.

Figure 5. - Sketch showing location of samples cut from broken turbine buckets for microexamination. Black areas indicate polished surfaces.

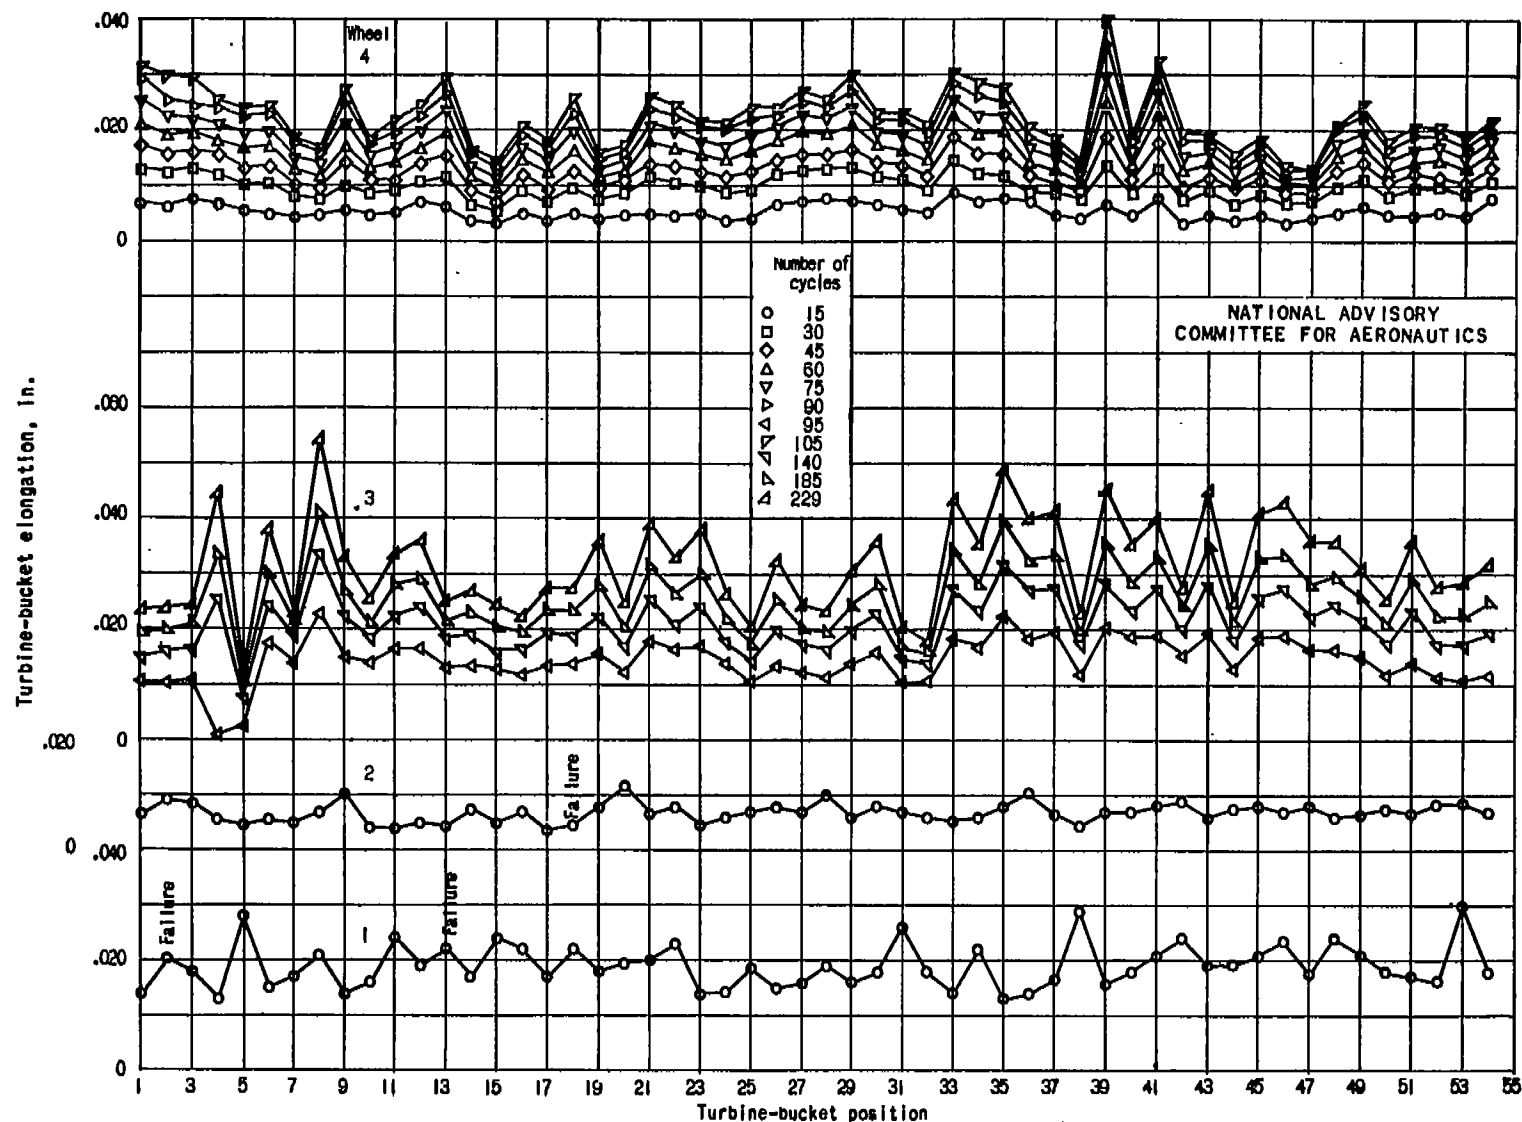
Turbine-bucket elongation. - The elongation of the turbine buckets for the four wheels is plotted in figure 12; the bucket failures are also indicated. The first bucket failures on wheels 1 and 2 so damaged the tips of all the other buckets that further measurements could not be made. The elongation data on wheels 3 and 4 are more complete; no bucket failures, however, have yet occurred on these wheels. All failures occurred at about the same distance from the bucket roots and the type of failure was the same in all cases (fig. 13).

Figure 12. - Variation of turbine-bucket elongation with time for four wheels investigated.

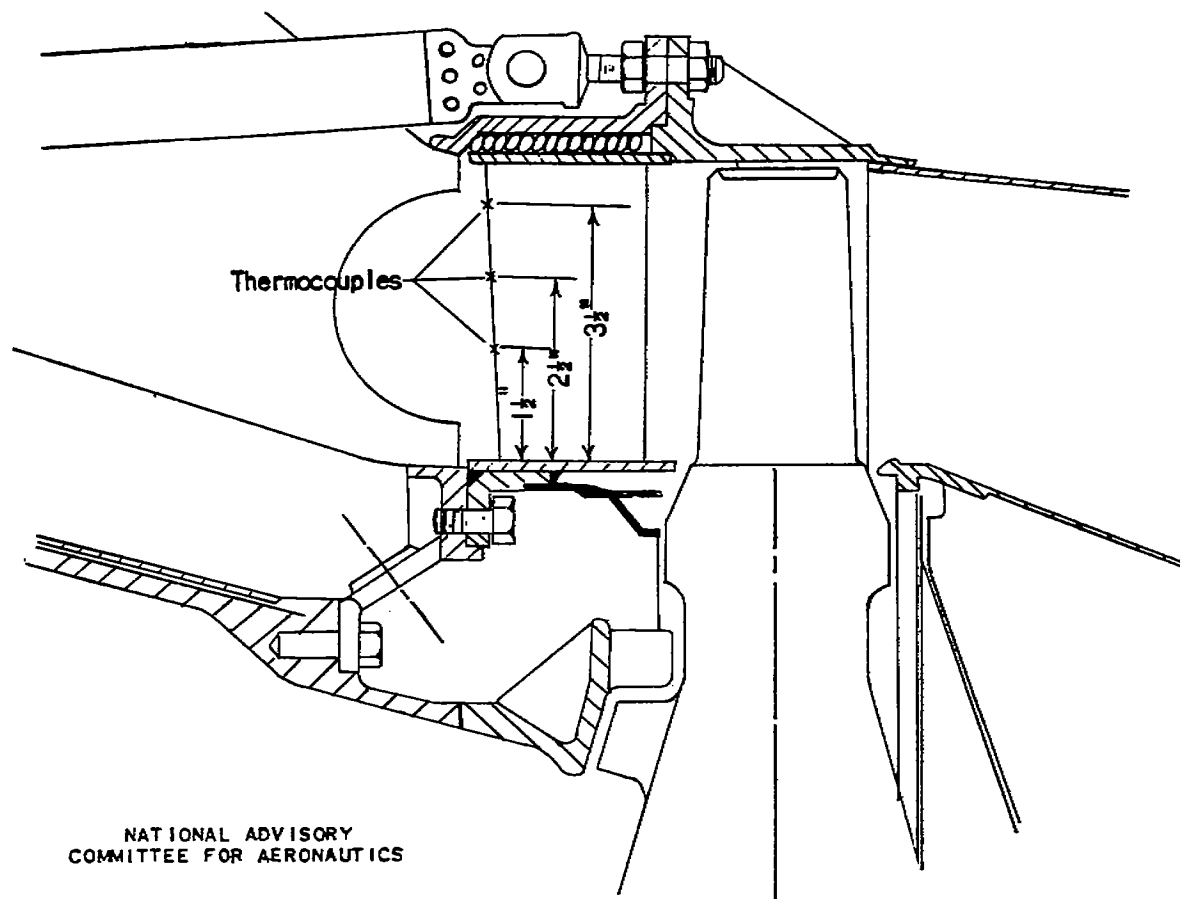
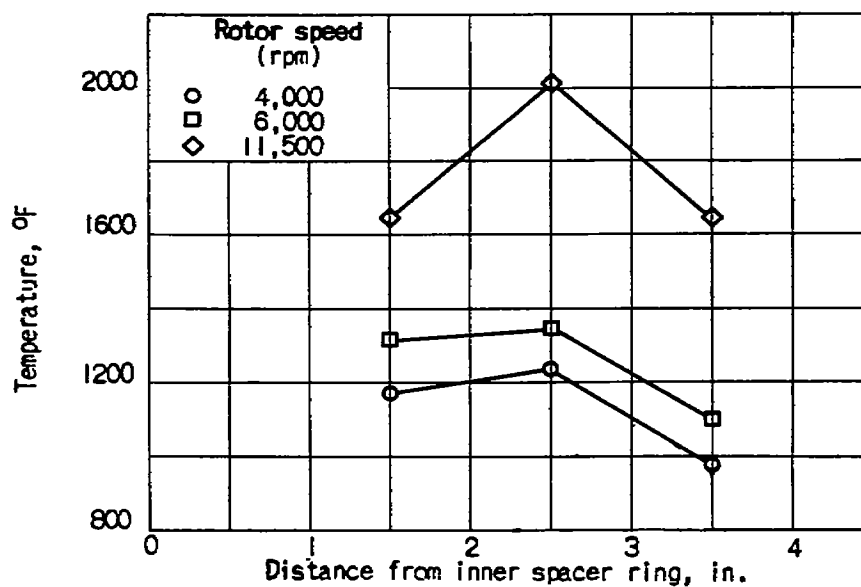
Nozzle-blade temperature. - The temperature variation along the leading edge of a turbine-nozzle blade located directly behind burner 1 is shown in figure 14. These temperatures were obtained by three chromel-alumel thermocouples located as shown in figure 14. The location of a thermocouple $2\frac{1}{2}$ inches from the inner spacer ring was chosen because in previous nozzle-blade failures most of the cracks were near this position. The data indicate that the hottest portion of the nozzle blade is about $2\frac{1}{2}$ inches from the inner spacer ring. The fractures on the trailing edge of the turbine buckets are approximately $2\frac{1}{2}$ inches from the root. Because the turbine-nozzle blades and the turbine buckets are supported in a different manner, the temperature distribution in them may not be the same; the bucket failures occurred, however, at the same radial location as the maximum measured nozzle-blade temperature.

Figure 14. - Temperature variation along leading edge of turbine-nozzle blade on center line of burner 1 in turbojet engine at various rotor speeds.
